While the Infotainment Hardware in the 4.2L X150's is the "same" from 2006.5MY to 2009MY, there was an updated software in the 2009MY vehicles that provided additional functionality, as well as some "secret" functionality that was only seen in the later models from 2010MY and 2012MY respectively...

2009MY is VIN range B27987 to B32752; this update is applicable for cars prior to VIN B27987.

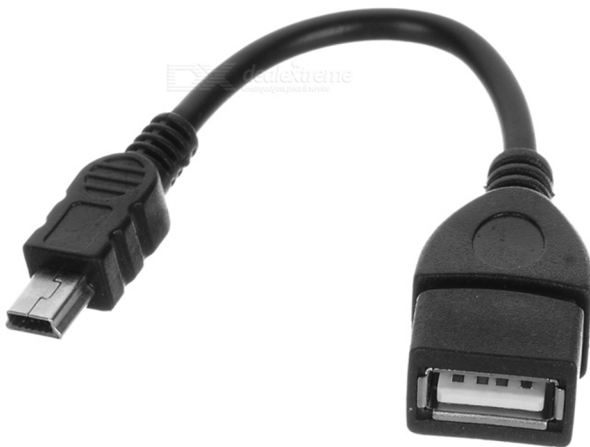
The software download to the FCDIM will often crash around 2hrs 10min, in which case the software can then be re-loaded using a USB stick and OTG cable (mini USB).

Use as small a USB stick as possible, ideally 256MB, 512MB, less than 1GB

\*\* This is also the process to recover crashed touchscreens.
